Test Report No.: SHAPH23002167133 **Date:** Mar 13, 2023 Page 1 of 4

Sample Name: Solvent ink

Manufacturer: POMA
Product Specification: UR420

Test Method: With reference to EN 14582:2016, analysis was performed by IC.

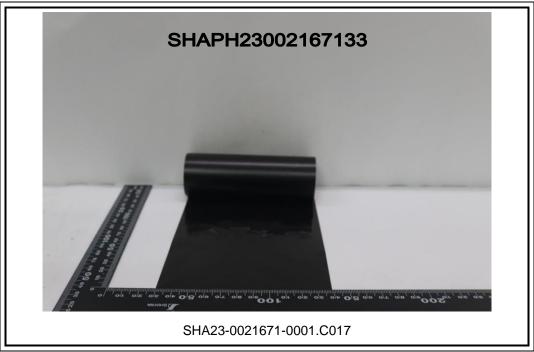
Sample Photo:

SN ID	Sample No.	SGS Sample ID	Description
SN1	017	SHA23-0021671-0001.C017	Black solid tape
